Inspection Connection

Inspector: Scott Van Wyhe
Inspection Date: 3/31/2017

Date: 3/31/2017	Time: 2:00 PM	Report ID: ICO17033110SVW
Property: Colorado Springs , CO 80922	Customer:	Real Estate Professional:

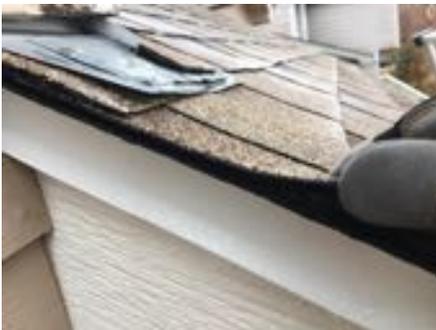
1.03.1 • The roof had one layer of roof covering material installed at the time of the inspection.

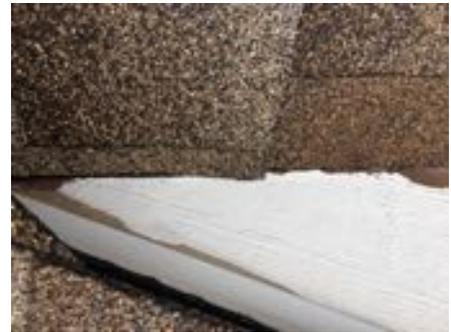
1.09.1 • Wall flashing at the front of the house was missing. This may allow moisture intrusion of the exterior walls. A qualified contractor should evaluate and repair or replace as necessary.

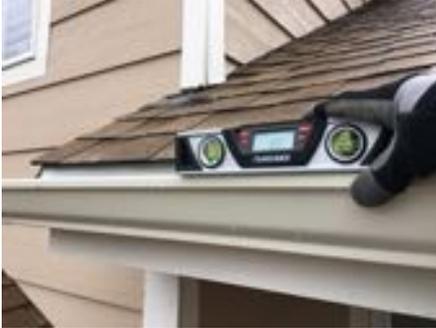
1.19.1 • The roof drainage system consisted of conventional gutters hung from the roof edges feeding downspouts, which route run-off away from the property foundation. The roof drainage system appeared to be in serviceable condition at the time of the inspection. The gutters appear intact, but due to the lack of recent rain, determining if gutters leak at seams or spill water was not possible at the time of the inspection.

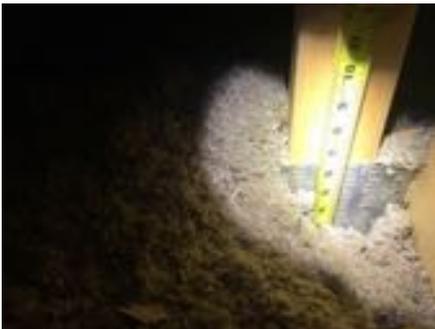
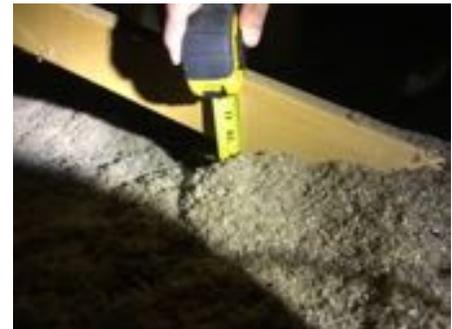
2.04.1 • The blown fiberglass and fiberglass batt (1 inch = R2.5-R4.3) insulation in the attic was about eight inches thick. Insulation levels are specified by R-Value. R-Value is a measure of insulation's ability to resist heat traveling through it. The higher the R-Value the better the thermal performance of the insulation. Current standards for existing wood-framed buildings for this climate and location are R38-R60. Recommend increasing insulation to achieve current standards as necessary.

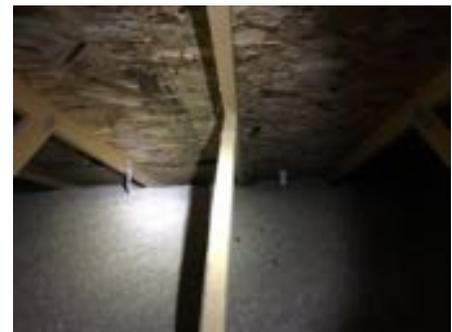
2.05.1 • The attic ventilation appeared to be satisfactory, and was provided by static roof vents ("turtle vents").

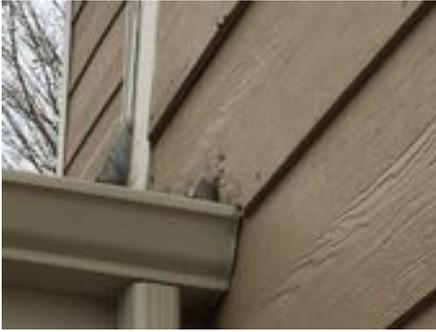
3.01.1 • The siding at the rear of the home is damaged. A qualified contractor should evaluate and repair or replace as necessary.
